WATER OPERATION AND MAINTENANCE

BULLETIN NO. 134

December 1985

THE EQUALIZATION OF STRAWBERRY AND SOLDIER CREEK RESERVOIRS BONNEVILLE UNIT CENTRAL UTAH PROJECT

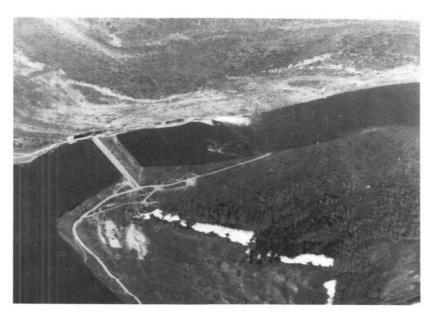
Aerial view of Strawberry Dam looking southwest. Soldier Creek Reservoir is to the left of Strawberry Dam in this photograph.

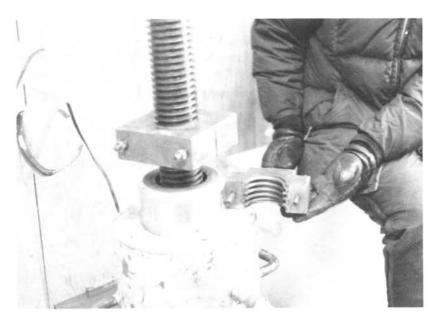
One-half of lower split nut showing threads.

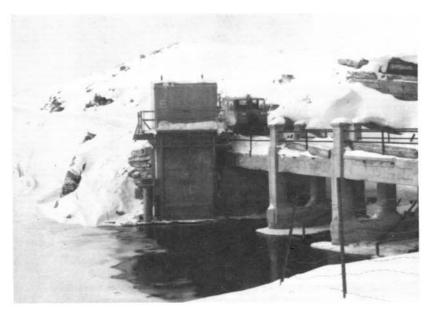
Wooden enclosure over hoisting platform. Note gate stems protruding through roof, both gates were open and water flowing through sluice tunnel.

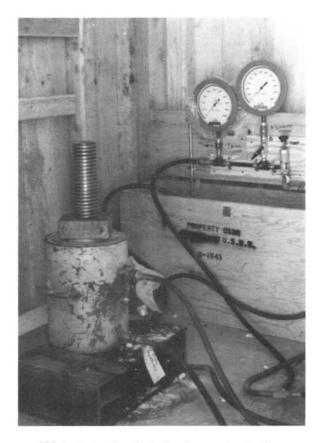
200-ton hydraulic cylinder in place on bearing frame.

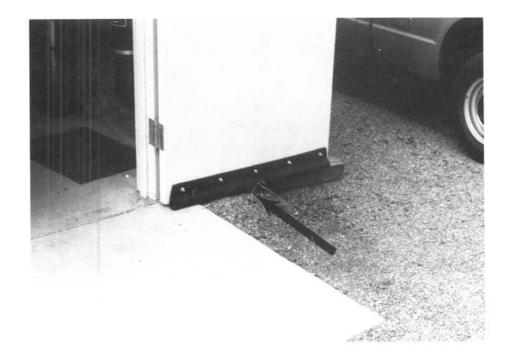
The photograph below illustrates one possible use for scrap rubber seals, typical of the type used on radial gates. The seal in the photograph serves as weatherstripping for a powerplant doorway and helps cut down on warm or cold air drafts. This seal could also be used on some windows to restrict rodent and bug invasions.

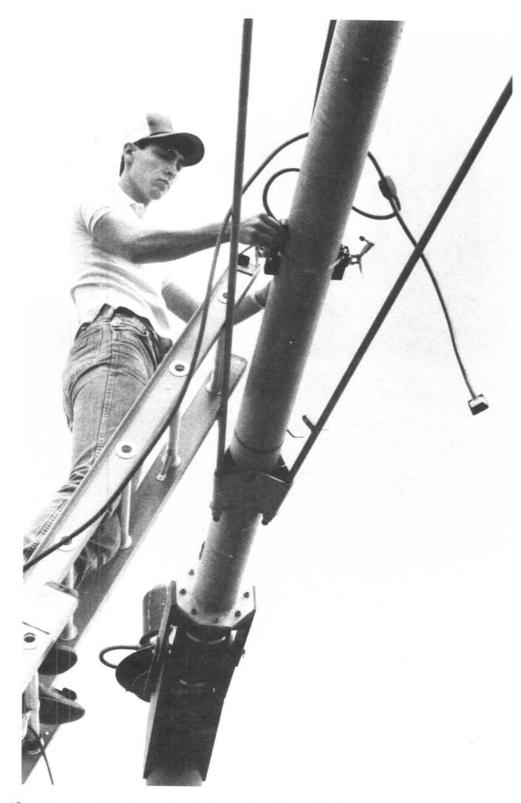
Darrel Evans, Apache, attaches flow-rate measuring equipment in pumping efficiency tests sponsored by OSU and the state Corporation Commission.

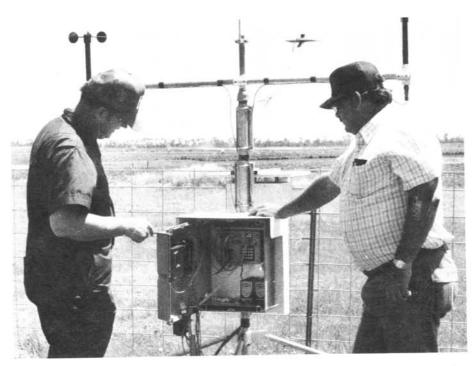
Extension agricultural engineers Delbert Schwab, left, and Sam Harp, examine a remote weather recording station used in irrigation scheduling.
